MISCELLANEOUS PAPER GL-86-19

FACILITIES TECHNOLOGY APPLICATION TESTS; FUEL-RESISTANT PAVEMENT SEALERS

August 1986 Final Report

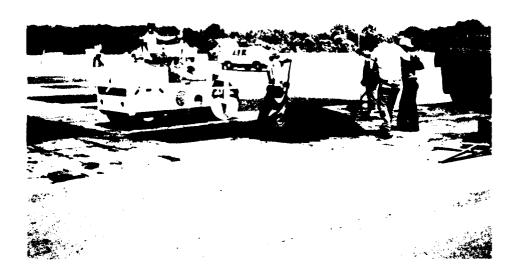
Photo 13. Patching fuel-damaged areas
